MCF5282 Device Errata

Supports: MCF5281 and MCF5282

MCF5282DE
Rev. 4
9/2008

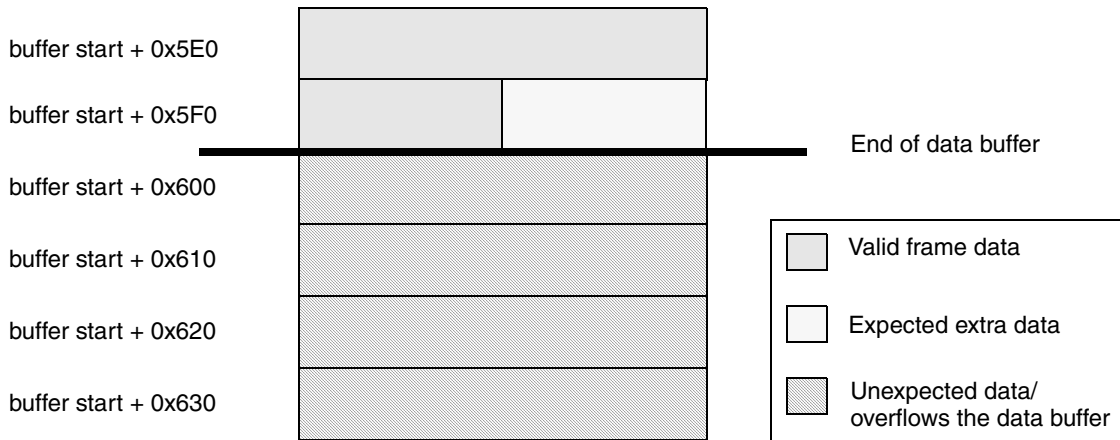
Figure 1. Buffer Overrun Example

When the FEC is connected to a 10BaseT network, if length of the data stored in a descriptor is not evenly divisible by 16 (not line-aligned), the FEC writes extra lines at the end of the buffer. The entire line that contains the last valid data is written and at least one extra line, but up to four lines after the end of the valid data can also be written. In most cases, this is not a problem because the extra lines of data continue falling within the limits of the buffer. However, if the valid data ends near the end of the buffer, the extra lines written by the FEC might be outside of the data buffer. This leads to corruption of the next buffer, descriptor, data, or code stored in the adjacent memory.

For example, as shown in [Figure 1](#), if the max buffer size is programmed to 0x600 and a frame that is 0x5F8 bytes long is received, a line is written starting at buffer start + 0x5F0. The first half of the line at buffer start + 0x5F0 is valid frame data that should be processed by the FEC driver; the second half of the line is additional data that is written because the FEC only writes complete lines. This data should be ignored by the FEC driver. So far, this is correct FEC behavior as originally specified. However, the FEC repeats the last line of valid data a number of times. The line at buffer start + 0x600 is written, and as many as three additional lines beyond the end of the data buffer could be written.

1. Only use 100BaseT.
2. Allocate extra lines for the receive data buffers. The actual allocated memory for each buffer should be equal to the receive buffer size programmed in the FEC's EMRBR register plus four lines (16 byte-sized lines).
3. Program the data buffer size one line larger than the max packet size (data buffer size = EMRBR + 0x40).
