PART NUMBER  
SSA-LXB8835

REV.  
A

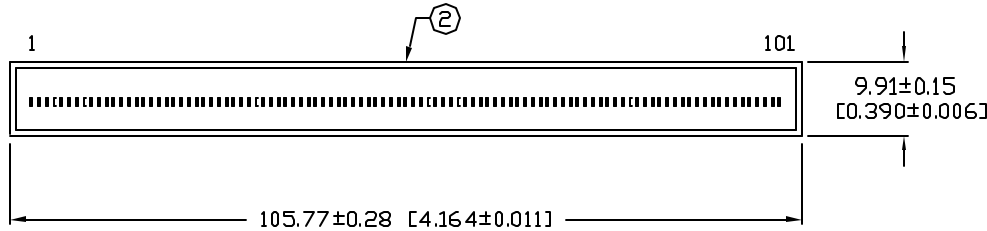
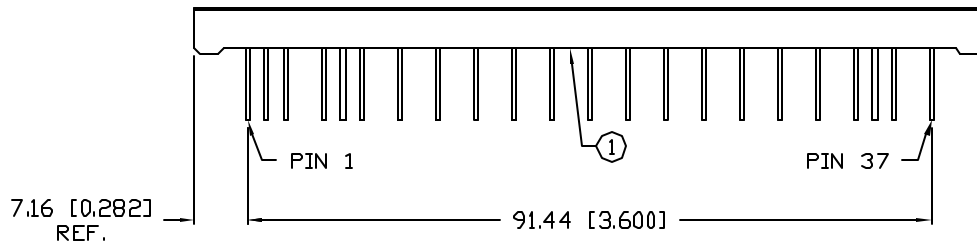
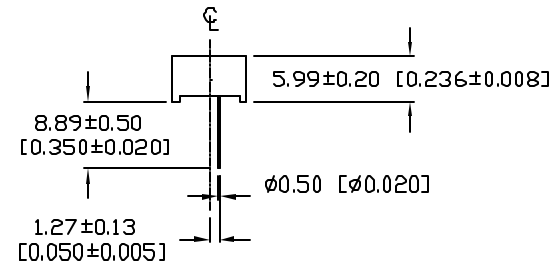
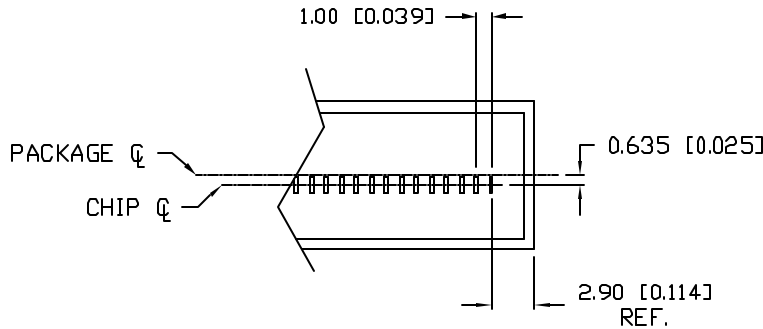
- 37 PIN LOCATIONS ON 2.54 [0.100] CENTERS.
- 0.25 [0.010] x 0.75 [0.030] RAILED EDGE.
- NO PIN LOCATION 4, 8, 10, 12, 14, 16, 18, 20, 22, 24, 26, 28, 30, 32, 36.
- TOLERANCES ARE NON-ACCUMULATED ON 101 LEDS.
