LUMEX
OPTO COMPONENTS INC.

T-1 MATING RIGHT ANGLE FAULT INDICATOR

DRAWING NUMBER
SSF-LXH2300XX

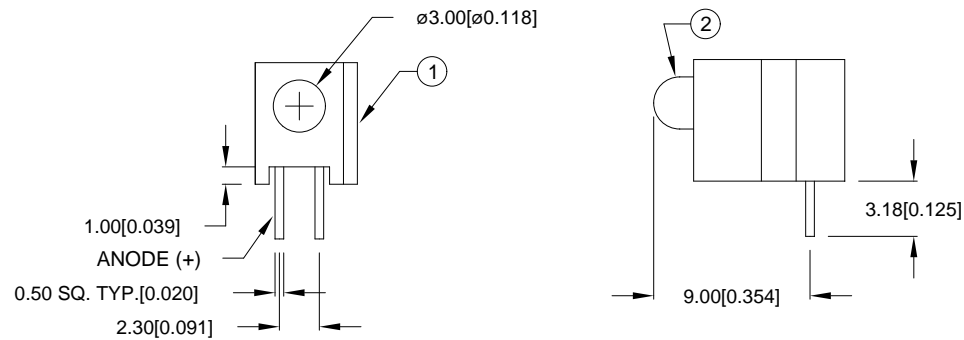
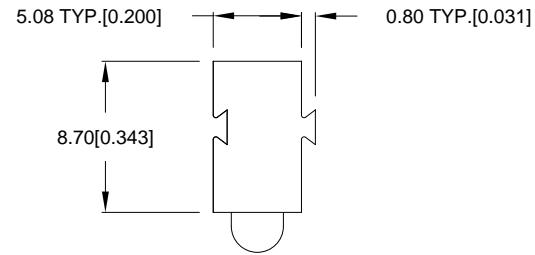
1. SSH-LXH2300 HOLDER, BLACK (1 PIECE).
2. SSL-LX306F4XX LED (1 PIECE).

OUR MANY YEARS OF EXPERIENCE DATA ACCUMULATION INDICATE THAT SOLDER HEAT IS A MAJOR CAUSE OF EARLY AND FUTURE FAILURE. PLEASE PAY ATTENTION TO YOUR SOLDERING PROCESS.

UNLESS OTHERWISE SPECIFIED TOLERANCE IS $\pm 0.25\text{mm}$ ($\pm 0.010''$)
